## MINIMUM CRITERIA DETERMINATION CHECKLIST

**TIP Project No.:** BR-0009

**Project Location:** Bridge #100079 on NC 9 over the Broad River in Buncombe County (Division 13).

**Project Description:** The North Carolina Department of Transportation (NCDOT) plans to replace Bridge #100079 on NC 9 over the Broad River (TIP # BR-0009) in Buncombe County (Division 13).

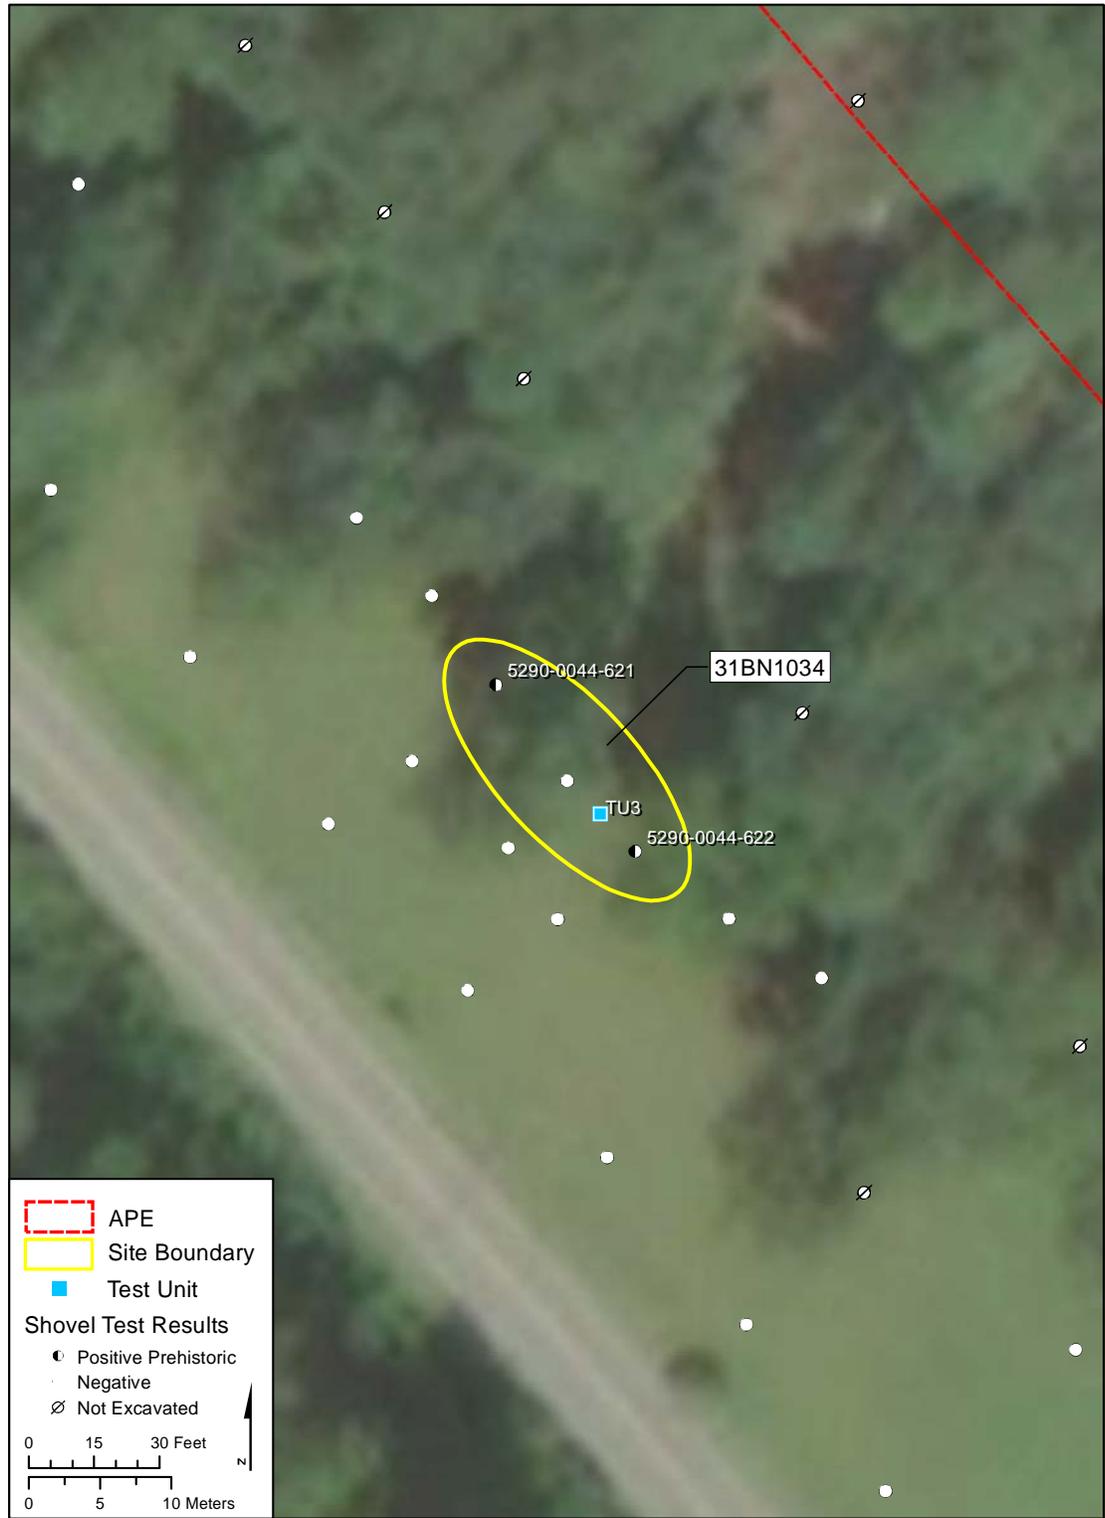
Figure 5. Map of Site 31BN1034

Six 7.5-meter interval shovel tests were excavated during the site delineation (Figures 5 and 6). Although Shovel Tests 621 and 622 yielded artifacts, none of the surrounding tests were productive, and boundaries of 10x23 meters were established for the site.

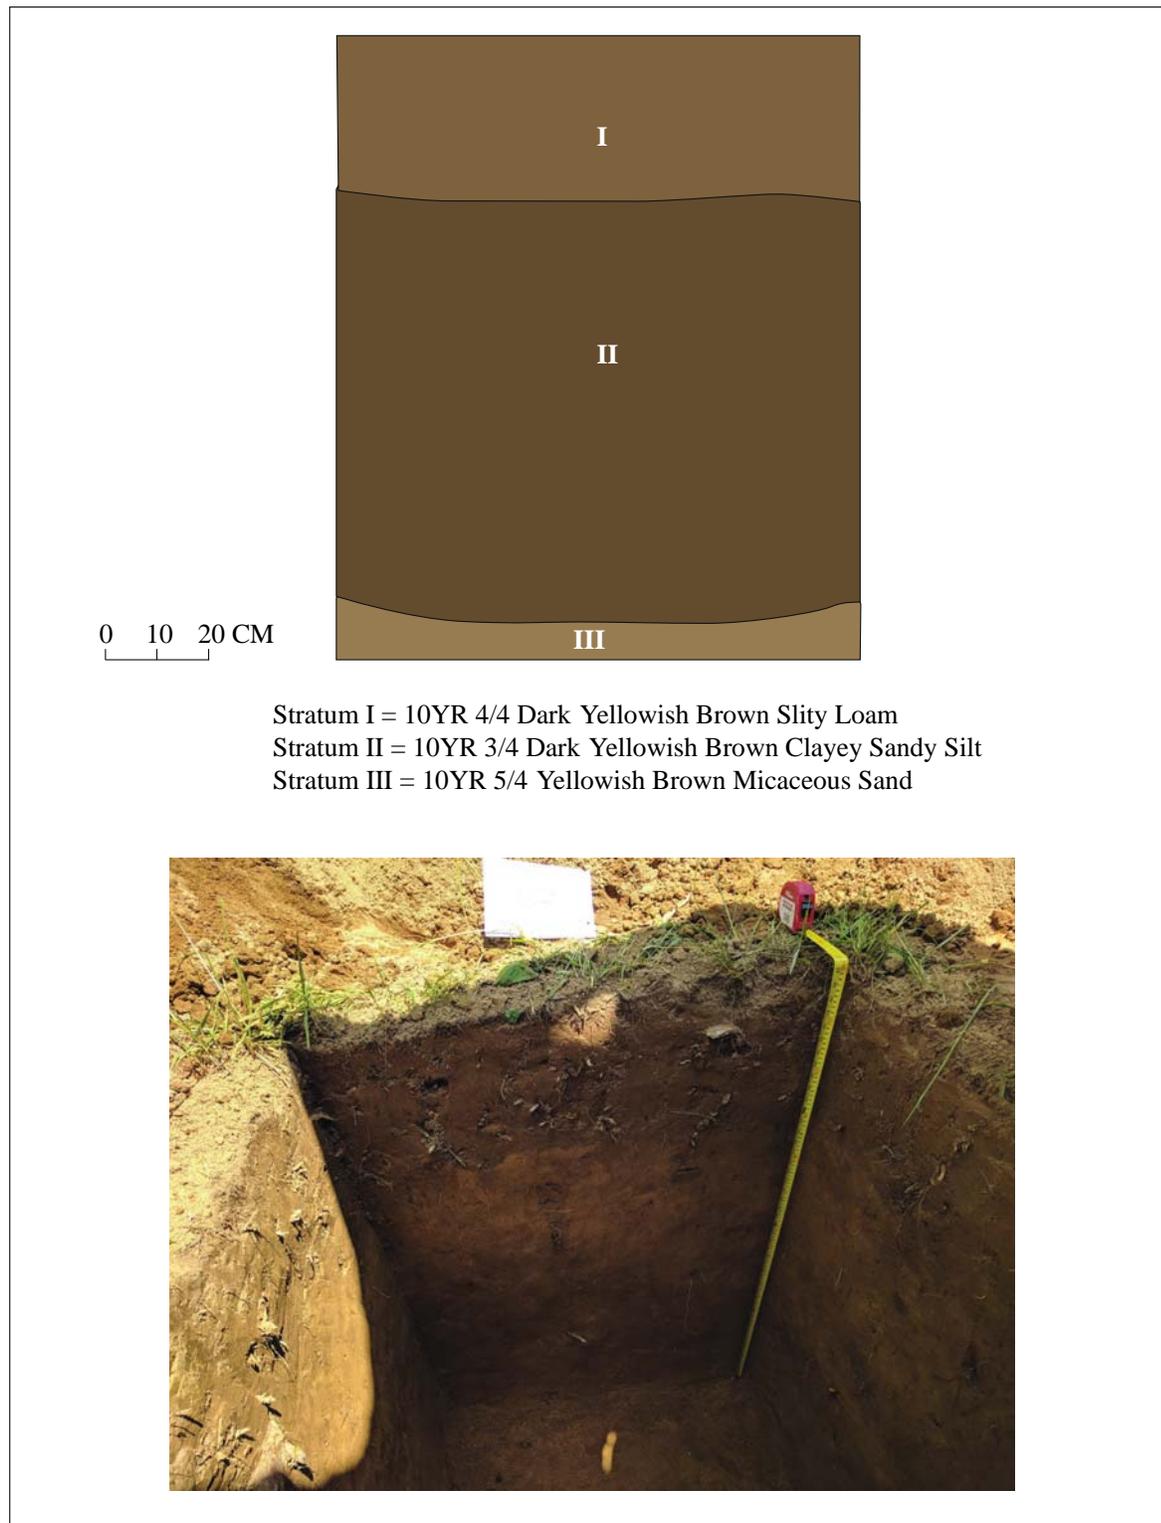
Figure 7. Test Unit 3 at Site 31BN1034, East Profile Sketch and Photograph

Test Unit 3 was placed near the Shovel Test 622 ceramic artifact concentration, at N502 E498. Four 10-centimeter levels were excavated from this 1x1-meter test unit (Figure 7). All soils were screened through 0.25-inch hardware cloth. Levels 1 (0-10 cmbs), 2 (10-20 cmbs), and 3 (20-30 cmbs) contained a dark yellowish brown (10YR 4/4) silty loam plow zone (Stratum I). Level 4 (30-40 cmbs) was excavated into Stratum II. This stratum contained dark yellowish brown (10YR 3/4) clayey loam. After controlled excavation of the first 40 centimeters did not locate any artifacts, succeeding soils were removed in natural strata to a final depth of 120 centimeters below the ground surface, where excavators encountered an alluvial deposit of coarse yellowish brown (10YR 5/4) micaceous sand (Stratum III). No artifacts, features, or soil anomalies were encountered during the excavation of the succeeding strata.

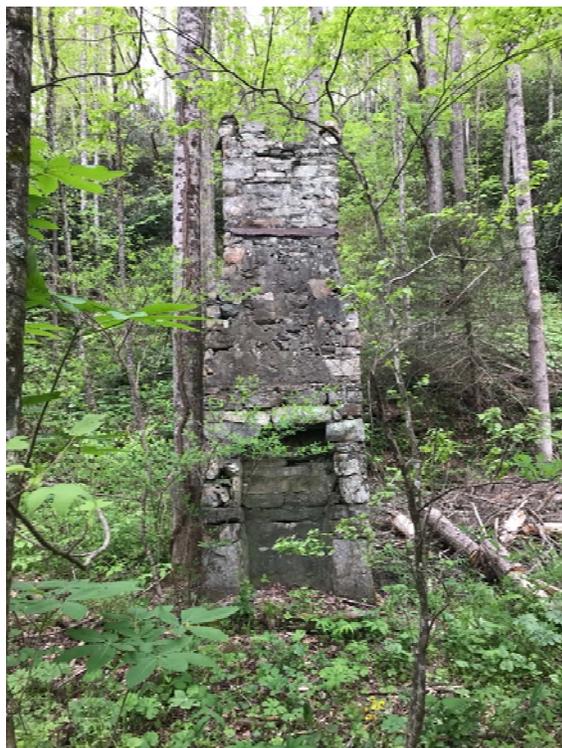
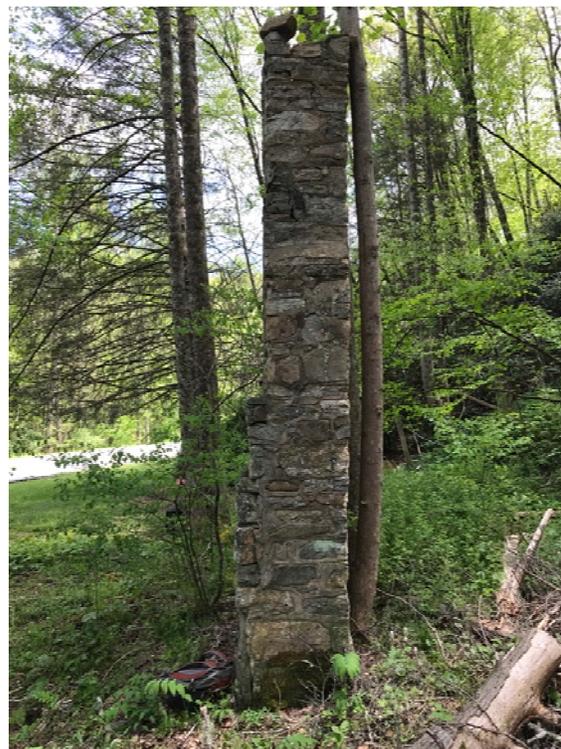
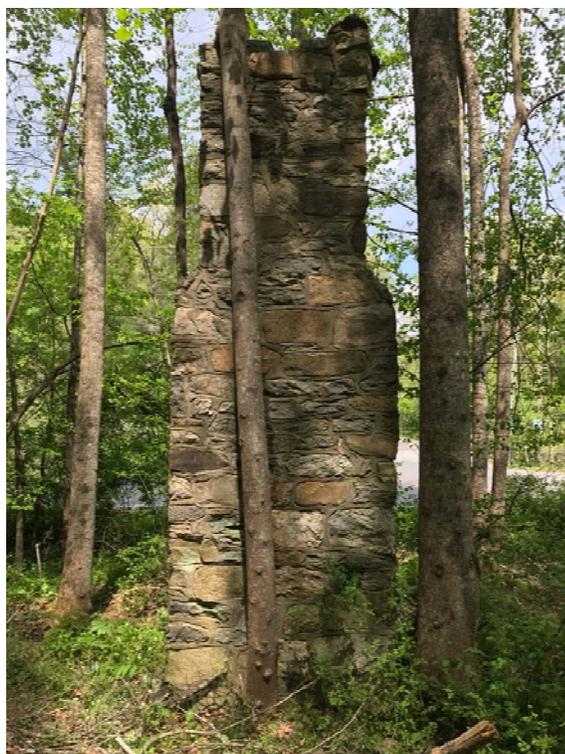
Figure 9. Chimney at Site 31BN1035

The chimney measured 80x160 centimeters in plan and was constructed of stone and mortar (Figure 9). The east-facing fireplace included an elevated stone hearth. A horizontal piece of standing seam metal roofing was embedded in the upper chimney, and mortar present on the interior (eastern) chimney face. No foundation or pier supports were located during the site evaluation. The position of the chimney suggests the house extended into the NC 9 right of way, and it is highly probable that standing structural elements in the area were demolished during road construction. Though survey testing did not locate any artifacts near the chimney, five 7.5-meter interval shovel tests were excavated during the site evaluation (Figures 10 and 11). These tests revealed 30 centimeters of brown (7.5YR 3/4) silty clayey loam overlying reddish yellow (7.5YR 7/8) silty clay subsoil. One test, at N507.5 E500, produced seven historic artifacts from a depth of 0-30 centimeters below the ground surface. This test location and the chimney location indicate the site measures 15 meters in diameter.

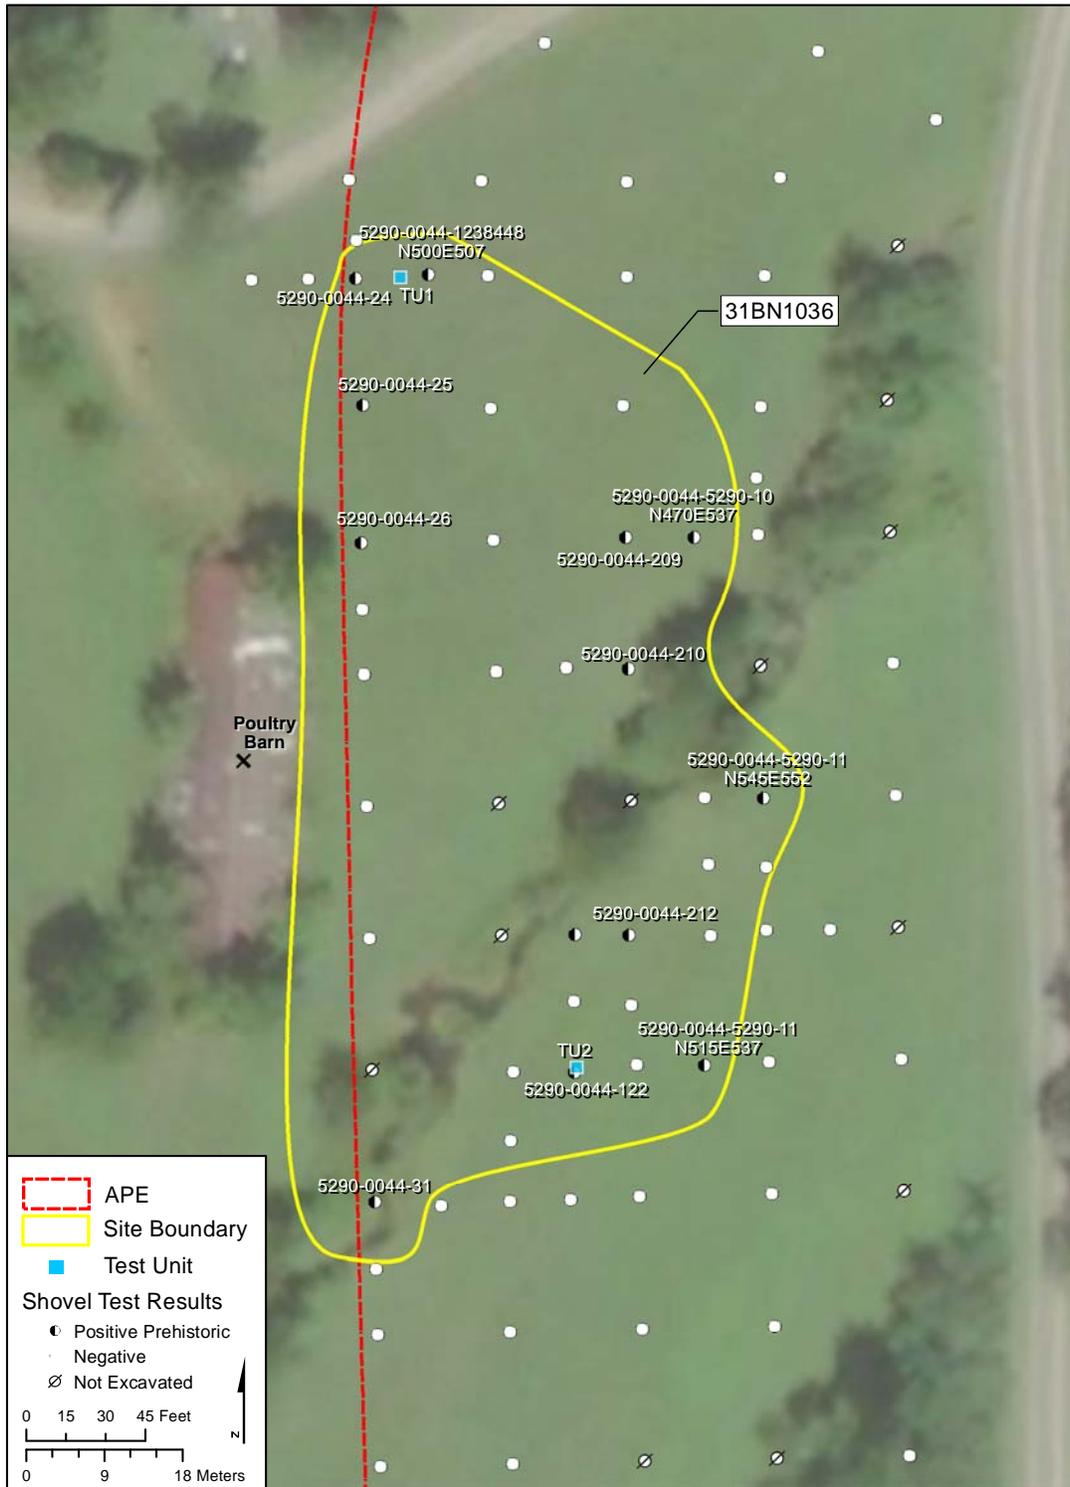
Figure 13. Map of Site 31BN1036

Thirty-seven 15-meter- and 7.5-meter-interval shovel tests were excavated during the survey and site evaluation (Figures 13 and 14). These tests revealed two principal soil profiles. Soils encountered in the northern half of the site included 30-40 centimeters of strong brown (7.5YR 4/6) silty clay overlying dark brown (7.5YR 3/2) clay and brown (7.5YR 4/4) clay subsoil. Shovel tests near Clear Branch uncovered 20-40 centimeters of brown (10YR 4/3) loamy silt overlying yellowish brown (10YR 5/4) sand. These soil textures and the proximity to the stream attest to the presence of alluvial activity in this area.

There were 13 positive tests located within site 31BN1036, indicating the artifact deposit measures 59x126 meters and extends to a depth of 74 centimeters below ground surface. There were 38 precontact artifacts and unmodified stones collected from site 31BN1036 shovel tests, including seven ceramic fragments, 23 lithic artifacts, and six unmodified stones (Table 1). The fragments had fine or medium sand-tempered pastes with plain, cord-marked, fabric-impressed, or eroded surface treatments. Though the surface treatments were not definitively identified to a precontact ceramic series, paste characteristics resemble the Middle Woodland period Connestee ceramic type (Keel 1976). Thermally altered rock was also identified at the N455 E500 shovel test, but not collected.

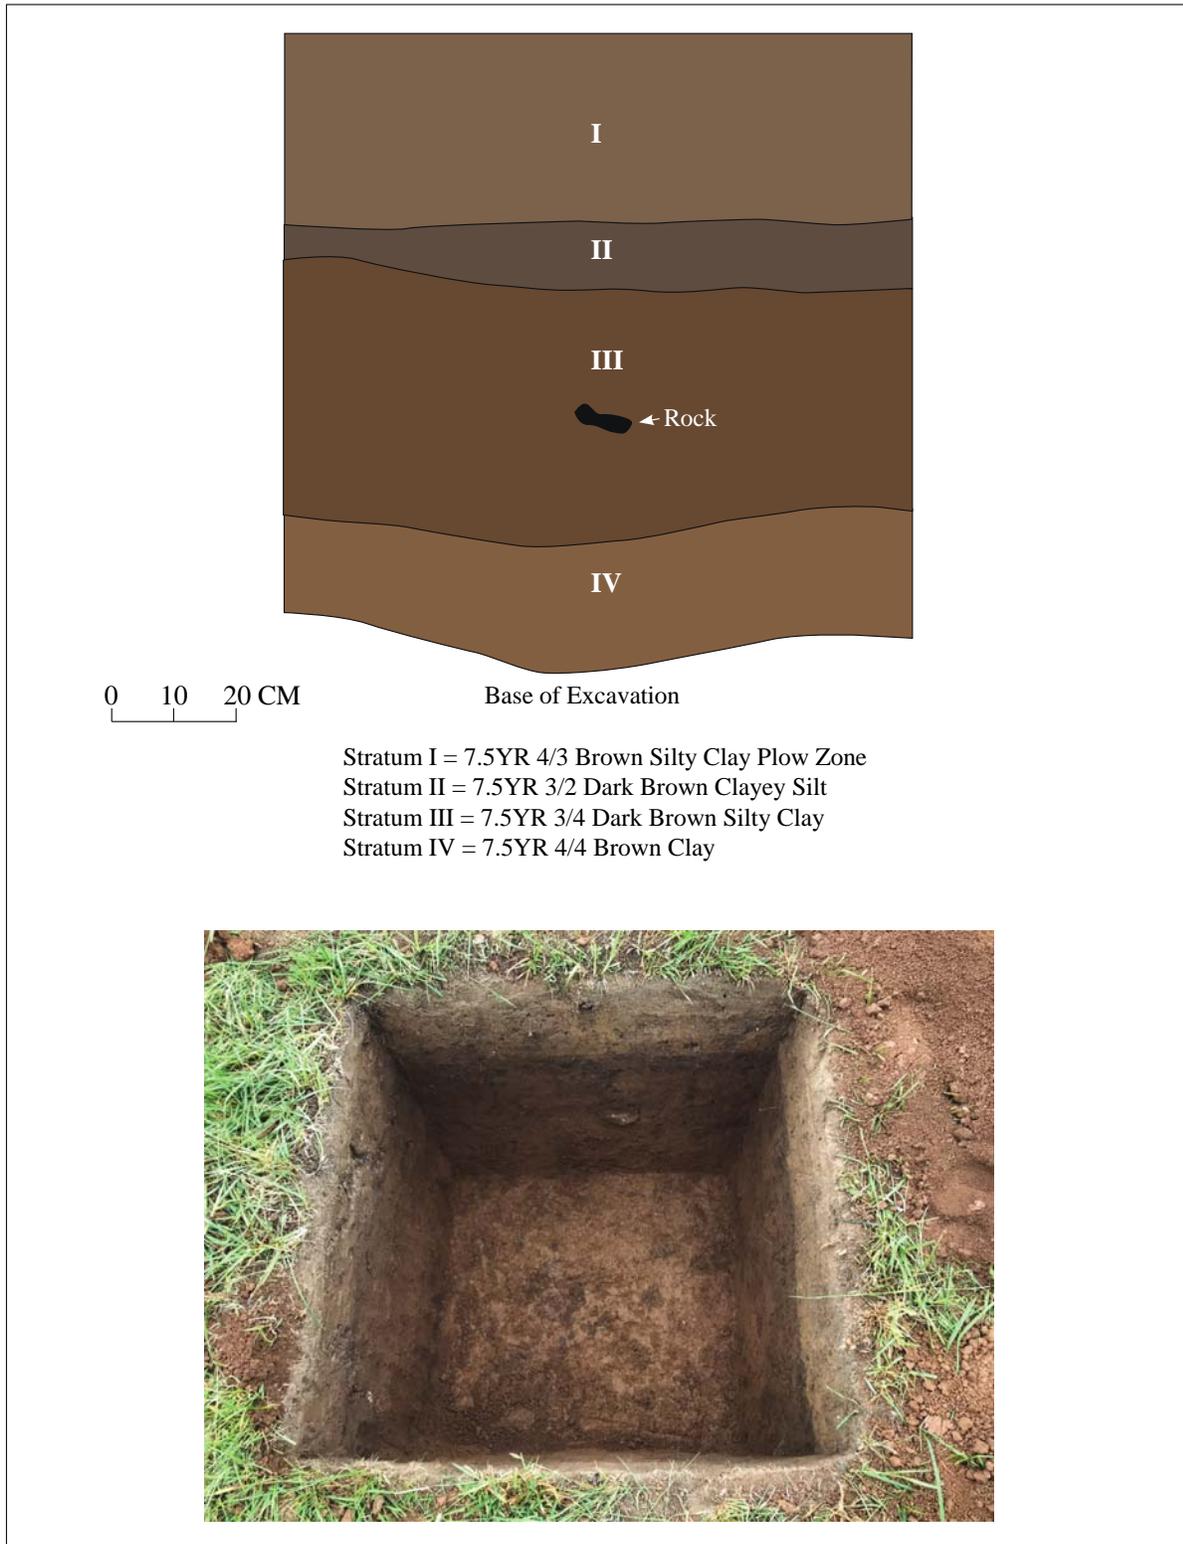
Figure 15. Test Unit 1 at Site 31BN1036, North Profile Sketch and Photograph

Nine levels were excavated in Test Unit 1, which uncovered four strata (Figure 15). Levels 1, 2, and 3 were excavated through Stratum I, a brown (7.5 YR 4/3) silty clay plow zone. Level 4 (30-44 cmbs) was inclusive of Stratum II. This stratum represented a zone of undisturbed A-horizon soil and was dark brown (7.5 YR 3/4) clayey silt that transitioned into Stratum III, a dark brown (7.5 YR 3/4) silty clay 40 centimeters below the ground surface. Stratum III was noticeably less compact than the upper strata and contained several cobble- and boulder-sized rocks (per the Wentworth Scale). This stratum was sampled with Levels 5, 6, and 7. Soils in Levels 8 and 9 (Stratum IV) were also more compact than Stratum II. This brown (7.5 YR 4/4) clay subsoil did not yield any artifacts, and excavation was terminated at 94 centimeters below ground surface (Table 2).

Test Unit 1 revealed a plow zone (Stratum I) overlying a 14-centimeter band of undisturbed A-horizon soil (Stratum II). This zone had a comparatively higher artifact density and contained large ceramic fragments attributable to a primary deposition context. Given the presence of rocks and loose compaction observed in Stratum III, the A-horizon may have developed atop a colluvial deposit. The few artifacts collected from Levels 5, 6, and 7 likely resulted from post-depositional processes, such as bioturbation. The presence of compact, sterile subsoil (Stratum IV) beneath this layer indicates the colluvium did not bury any earlier cultural components. Although no features were identified in the Test Unit 1 excavation, the presence of an undisturbed A-horizon indicates subsurface features may be preserved within this part of site 31BN1036.

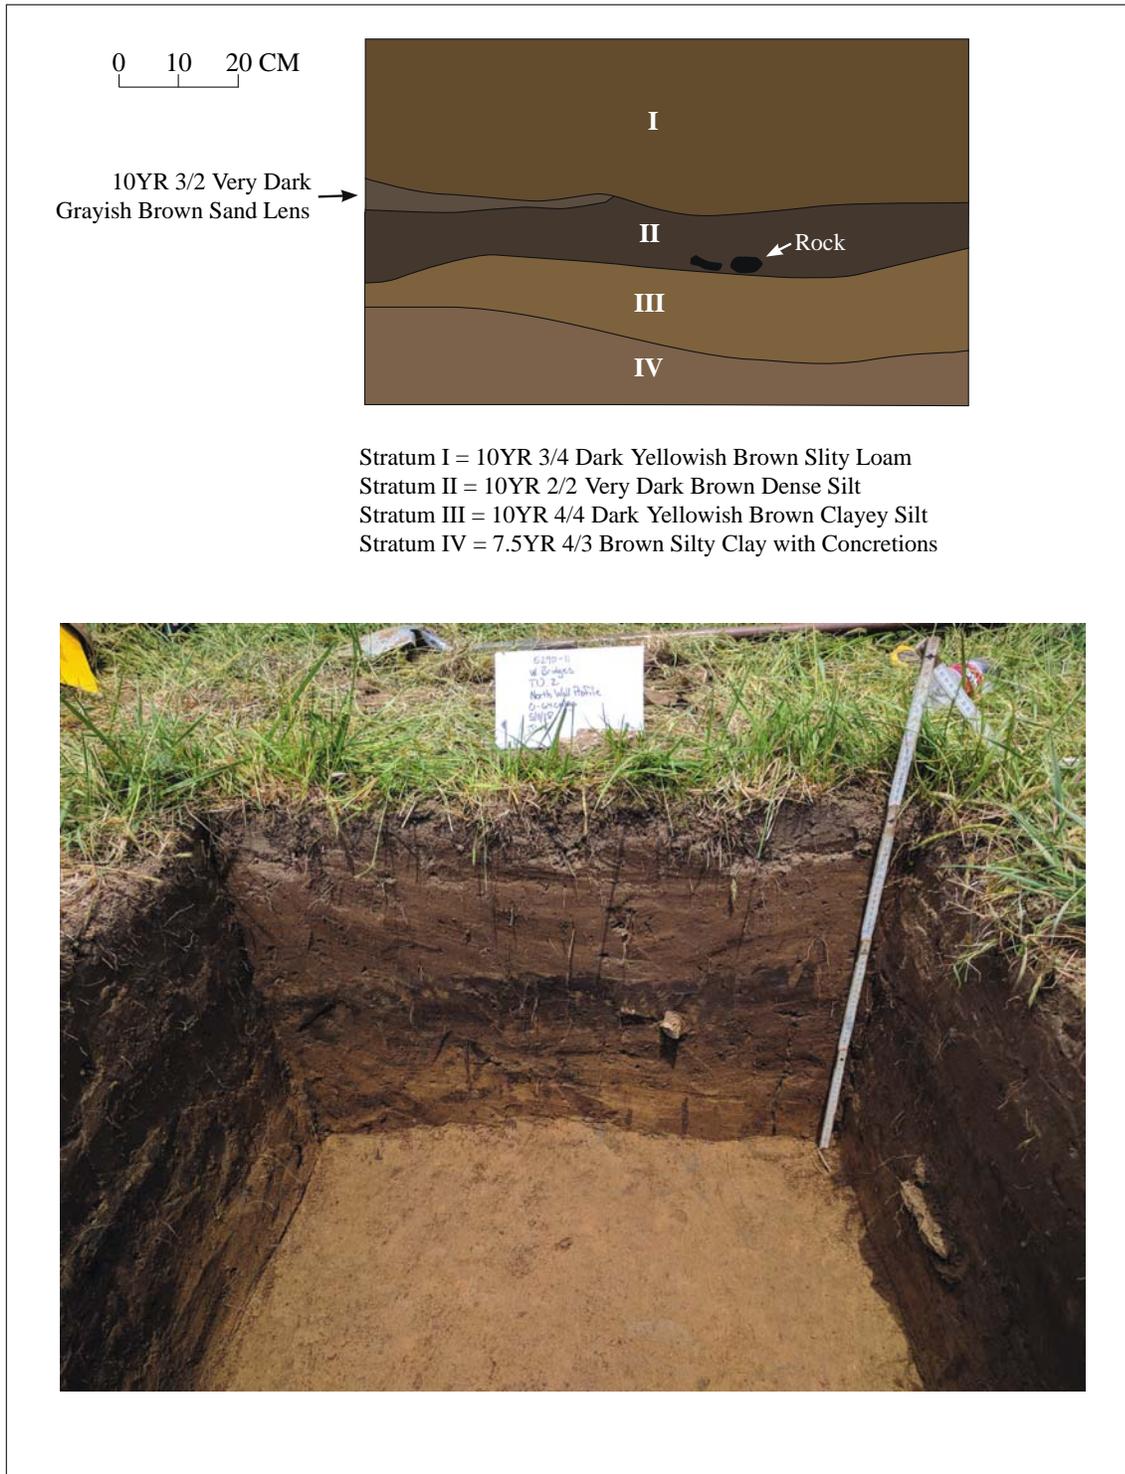
Figure 17. Test Unit 2 at Site 31BN1036, North Profile Sketch and Photograph

Stratum I produced most of the artifacts (n=24) found in Test Unit 2, including non-diagnostic quartz flake/flake fragments or quartz angular debris (Table 3). Two non-diagnostic chert flakes and an unmodified stone were also collected, as well as two medium sand-tempered eroded body sherds and one coarse sand-tempered plain body sherd from the plow zone.

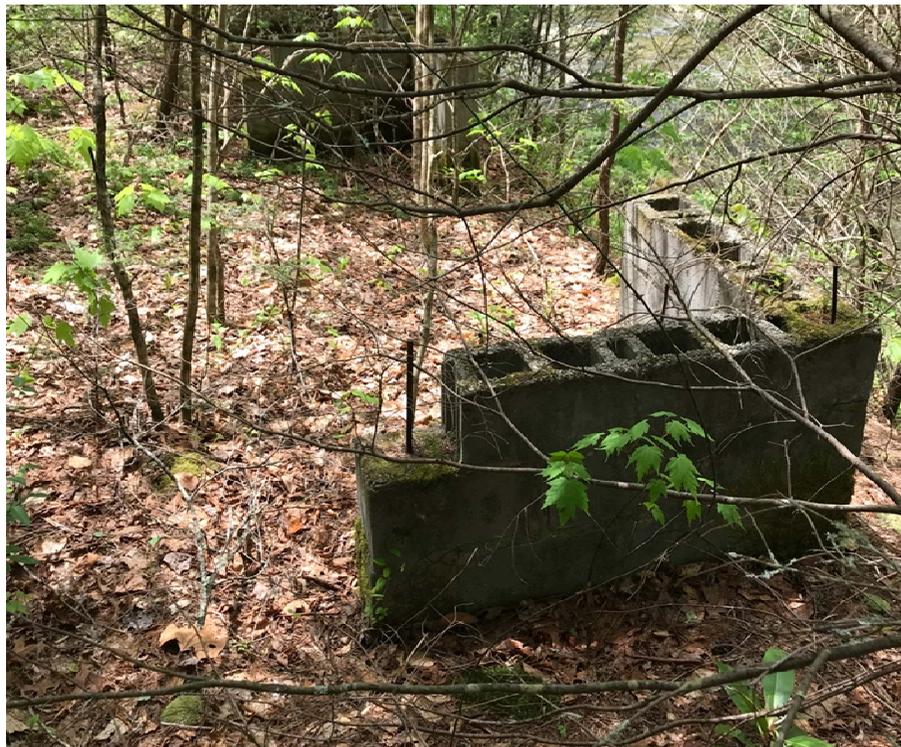
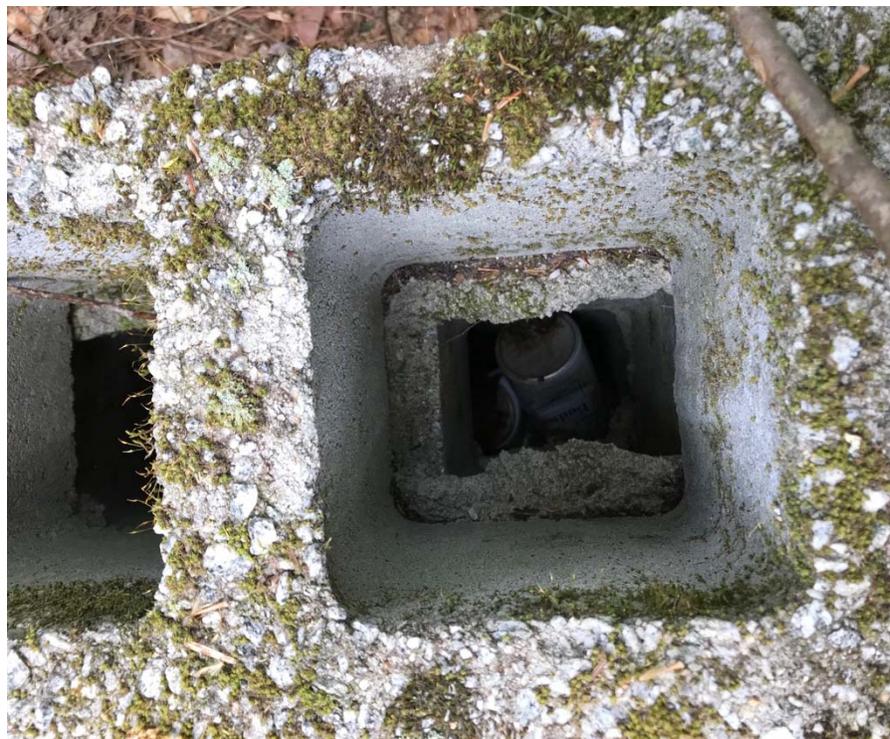
Figure 22. Partially Demolished Building Constructed in the Early 1970s

A) Concrete Block Corner

B) Cans Located Within the Block Wall
